Test Report No. 7191059121-MEC13-OKB
dated 20 may 2013

PERFORMANCE TEST
OF
ALUMINIUM FIXED GLASS WINDOW SYSTEM
(DGU ENCLOSED WITHIN A SET OF ADJUSTABLE BLIND)

ACCORDANCE WITH SS212: 2007

Unicos Tech Pte Ltd
33 Ubi Ave 3, #07-57 Vertex
Singapore 408868

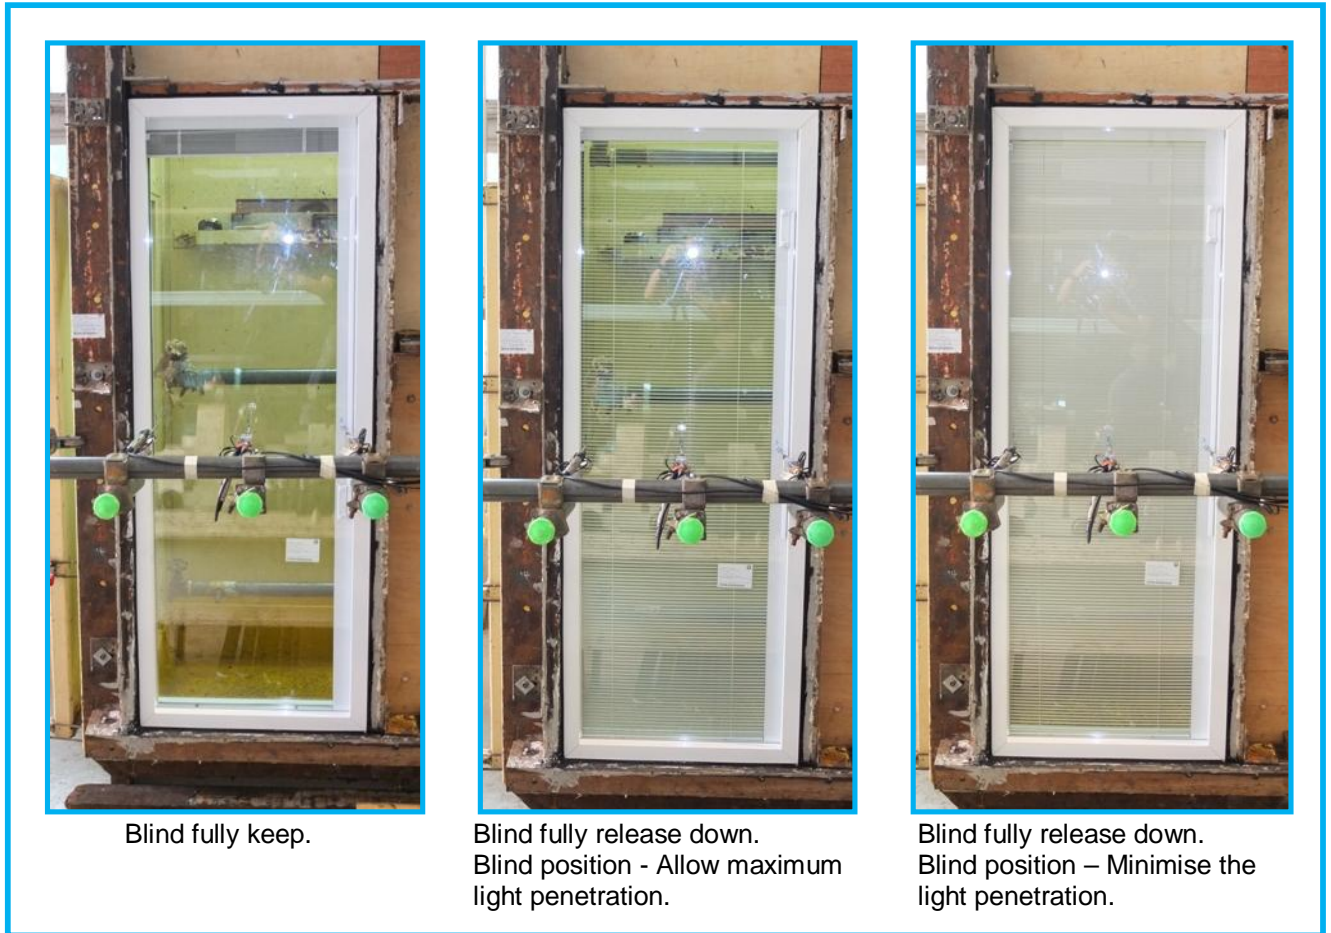
Overall window size : 620mm(W) x 1690mm(H)
Framework : Aluminium alloy
Glass type : 25.5mm thick, DGU tempered glass
(3.2mm thk, clear tempered glass + 15.1mm air space with Blind + 3.2mm thk, clear tempered glass)
Sealant : Polysulfide
Reference for details : 3 sheets of Company's window drawings.

Group photo 1: Mock-up test specimen (View from inside building).

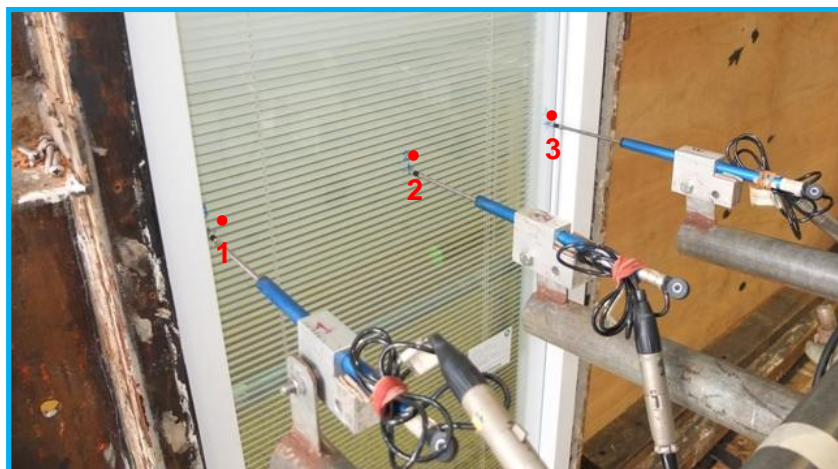
Photo 2: Location of transducer points on mock-up test specimen
(View from inside building)

Point	Displacement of Test Specimen (mm)					
	Span (mm)	Test Pressure	Relative Deflection at 1200 Pa	Test Requirements	Residual Deflection	
		1200 Pa			After Pre-load of 600 Pa	After Structural Load of 1200 Pa
1	500 Glass	0.65	1.82 (For information only)	Nil	0.02	0.05
2		3.30			0.06	0.10
3		2.31			0.06	0.13

Point	Displacement of Test Specimen (mm)					
	Span (mm)	Test Pressure	Relative Deflection at -1200 Pa	Test Requirements	Residual Deflection	
		-1200 Pa			After Pre-load of -600 Pa	After Structural Load of -1200 Pa
1	500 Glass	-0.65	1.96 (For information only)	Nil	-0.07	-0.02
2		-3.39			-0.21	-0.09
3		-2.22			-0.18	-0.17

Point	Displacement of Test Specimen (mm)	
	Residual Deformation after maximum test pressure of 1800 Pa was removed	Residual Deformation after maximum test pressure of -1800 Pa was removed
1	0.14	-0.16
2	0.43	-0.48
3	0.68	-0.66

Note: Refer to Figure 1 on page 7 for locations of deflection points.
